MAJOR REPAIR AND ALTERATION (Airframe, Powerplant, Propeller, or Appliance)

1. Aircraft	Make <p style="text-align: center;">Ryan</p>	Model <p style="text-align: center;">Navion B</p>
	Serial No. <p style="text-align: center;">NAV-4-2313B</p>	Nationality and Registration Mark <p style="text-align: center;">N5413K</p>
2. Owner	Name (As shown on registration certificate) <p style="text-align: center;">Putney, William W III Rodgers, Gail C</p>	Address (As shown on registration certificate) <p style="text-align: center;">5780 Balmoral Drive Oakland, CA 94619</p>

Description of alteration: This alteration removes a Narco Mk-12A NAV/COM, CDI, VOR Resolver, Glideslope Receiver and Power Unit. This alteration also installs a Bendix/King model KX-125 NAV/COMM and a Bendix/King model KI214 VOR/LOC - GS indicator.

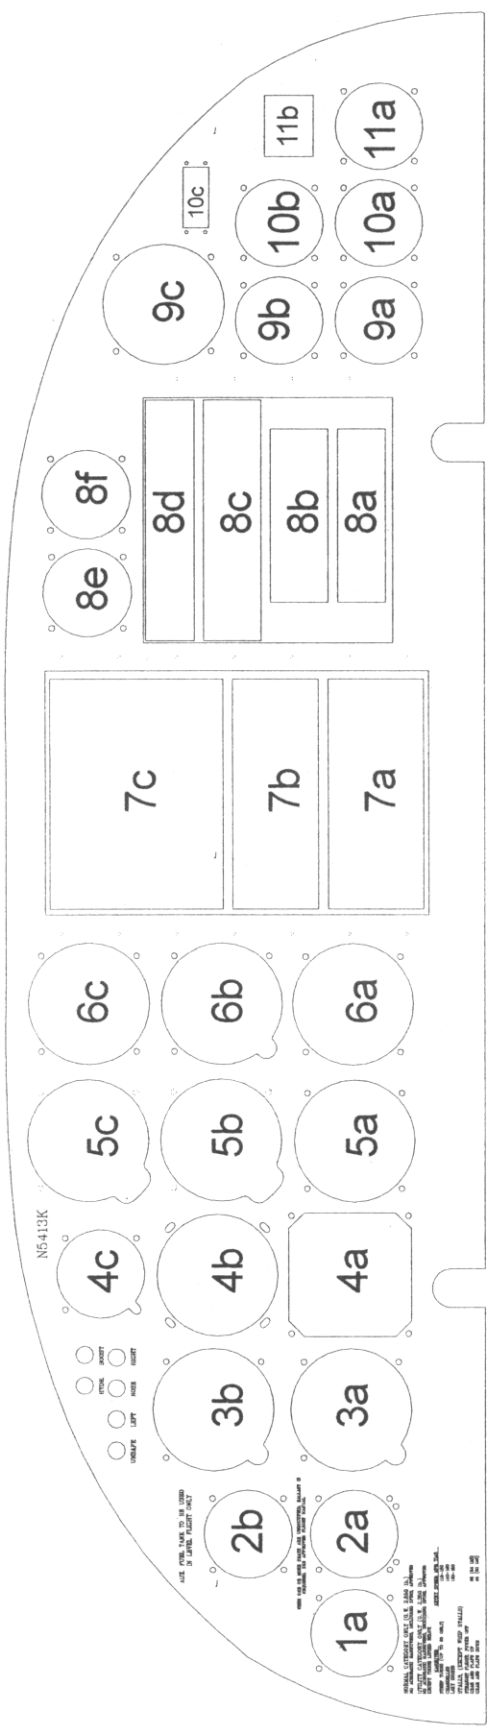
Description of work: The Narco radio and its wiring and accessories were removed and discarded. Installation of the new radio at location 7b and indicator at location 6b (see N5413K Panel dwg attached) were accomplished according to the installation instructions in the Bendix/King "KX 125 Communication Transceiver/Navigation Receiver Installation Manual" (manual number 006-00655-0001) and the King "KI214 VOR/LOC-OBS Indicator Installation Manual (manual number 006-0092-01). 6-#6-32 flathead screws attaché the radio tray to the radio rack. Audio inputs and outputs are provided to the aircraft's audio panel (see attached N5413K Audio drawing). The existing communication and navigation antennas were reused for this installation.
