MAJOR REPAIR AND ALTERATION (Airframe, Powerplant, Propeller, or Appliance)

8. Description of Work Accomplished (If more space is required, attach additional sheets. Identify with aircraft nationality and registration mark and date work completed.)
Reg: N5413K, SN: NAV-4-23148
Nationality and Registration Mark Date
 Purpose: This alteration enhances safety of flight by adding a standby alternator system, (B&C PN: BC410-1 & reg. PN: BC217-1A) which provides electrical power should the primary alternator fail while in flight.
 Necessity: If the Primary Alternator fails, the ship's battery provides limited power for navigation communications, transponder/ADS-B, pitot heat and lighting for a safe return and landing.
 Necessity for a Field Approval: This system may be installed by STC SA01066WI for similar aircraft, however the Navion B is not listed in the STC's AML.
 Description of Work Performed: The installation was accomplished IAW B&C Specialty Products Install Instructions-BC410 Rev C doc (8/21/07).

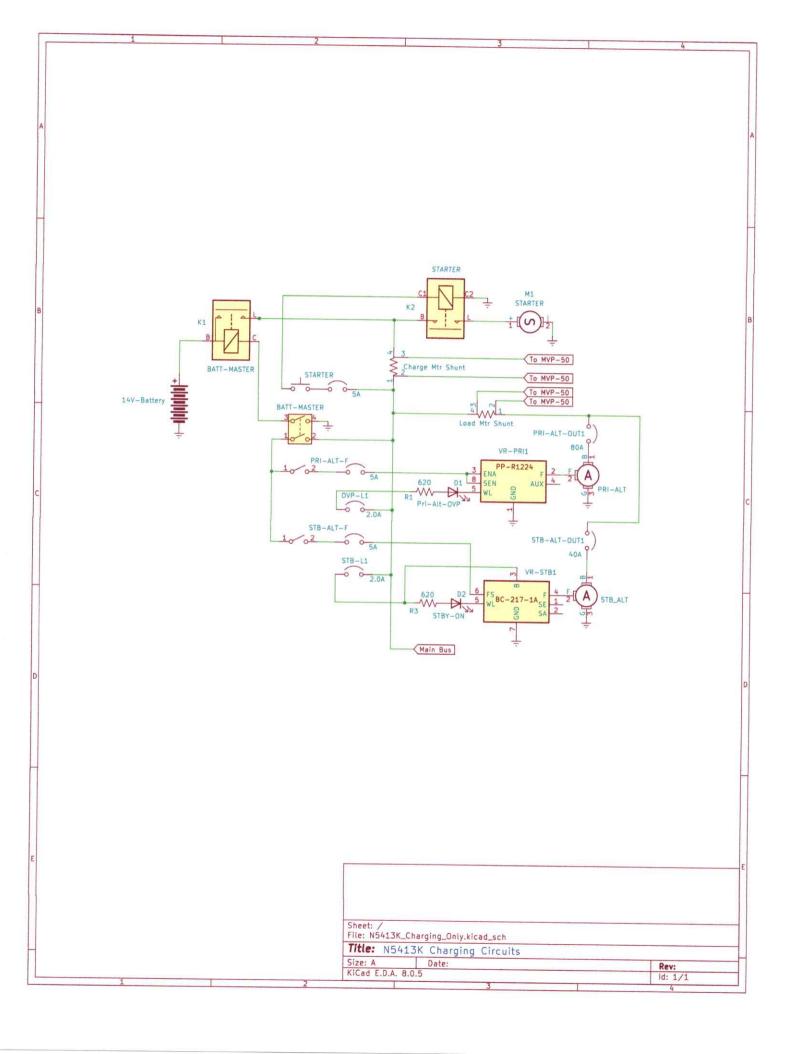
7) The following documents were inserted in the aircraft's Pilot's Operating Handbook; -Amended Weight and Balance ReportAmended Equipment List.
 8) Simplified electrical diagram. - This drawing depicts parts of the existing electrical system for context. - The following elements are added by this alteration; BC410 Standby Alternator "STB_ALT", BC217-1A Standby Alternator Controller "BC-217-1A", Output CB "STB-ALT-OUT", Field CB and control switch "STB-ALT-F", Indicator circuit components (LED "STBY-ON", 1 A CB "STB-L1", 620 Ohm Resistor "R3"). - No other changes/additions to the electrical system were made to accomplish this alteration.
Attached Documents; Simplified electrical diagram (1 Page)
======================================
