MAJOR REPAIR AND ALTERATION (Airframe, Powerplant, Propeller, or Appliance)

1. Aircraft	Make <p style="text-align: center;">Ryan</p>	Model <p style="text-align: center;">Navion B</p>
	Serial No. <p style="text-align: center;">NAV-4-2313B</p>	Nationality and Registration Mark <p style="text-align: center;">N5413K</p>
2. Owner	Name (As shown on registration certificate) <p style="text-align: center;">Putney, William W III Rodgers, Gail C</p>	Address (As shown on registration certificate) <p style="text-align: center;">5780 Balmoral Drive Oakland, CA 94619</p>

Description of alteration: This alteration removes a Narco Mk-12A NAV/COM, CDI, VOR Resolver and Power Unit. This alteration also installs a TKM, Inc model MX-12 NAV/COM and a TKM model MC60 Navigation Converter and Indicator.

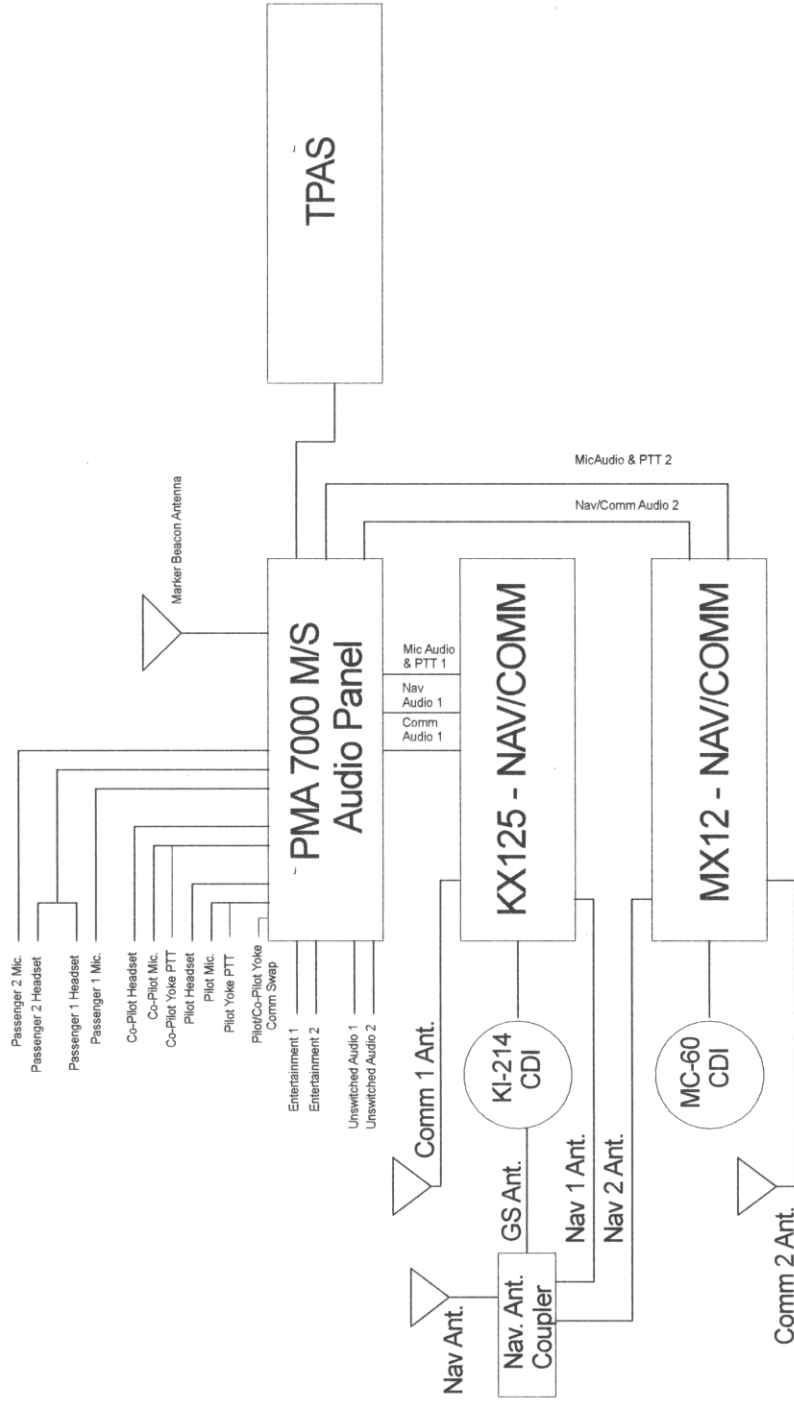
N5413K - Audio

Description of work: The Narco radio and its wiring and accessories were removed and discarded. Installation of the new radio and indicator were accomplished according to the installation instructions in the TKM "MX12 Nav-Comm Owners Manual" and the TKM "MC60 Navigation Converter and Indicator Operation and Installation" manual. The MX-12 and the MC60 are located in the instrument panel at 7a and 6a respectively (see attached drawing N5413K Panel). Audio inputs and outputs are provided to the aircraft's audio panel (see attached N5413K Audio drawing). The existing communication and navigation antennas were reused for this installation.
