**NORTH AMERICAN AVIATION • INC.**

SERVICE LETTER NO. 2

SUBJECT: PROPELLER CONTROL FRICTION LOCK

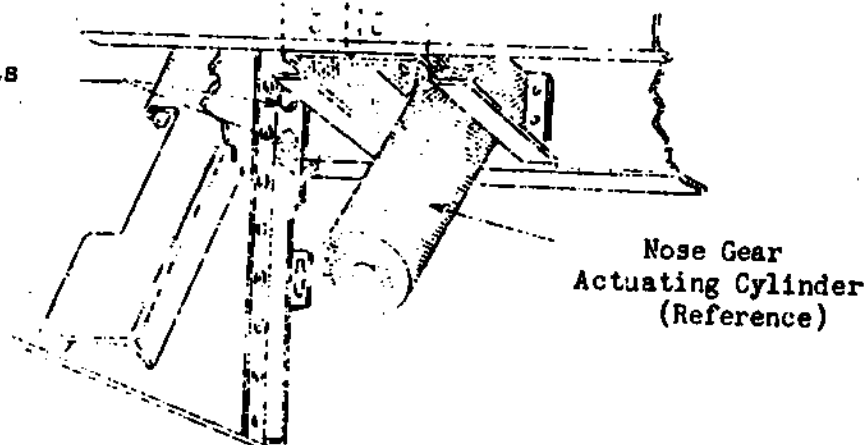
View looking up and aft  
into nose wheel well

At the nose gear retracting cylinder attaching cross member, where ends attach to nose wheel well side spar, right hand side, upper corner (see sketch), determine if the two (2) proper  $3/16$ " high shear rivets are installed. If there are two (2)  $1/8$ " rivets, they should be removed, holes drilled out with a No. 12 drill and two (2) AN 3- bolts installed. On the left hand side, upper corner, see if the two (2) proper  $5/32$ " dural rivets are installed, if there are  $1/8$ " rivets, remove same, drill out to  $5/32$ " and install two (2) AN 442-AD5 ( $5/32$ ) rivets or drill out with No. 12 drill and install two (2) AN 3- bolts.

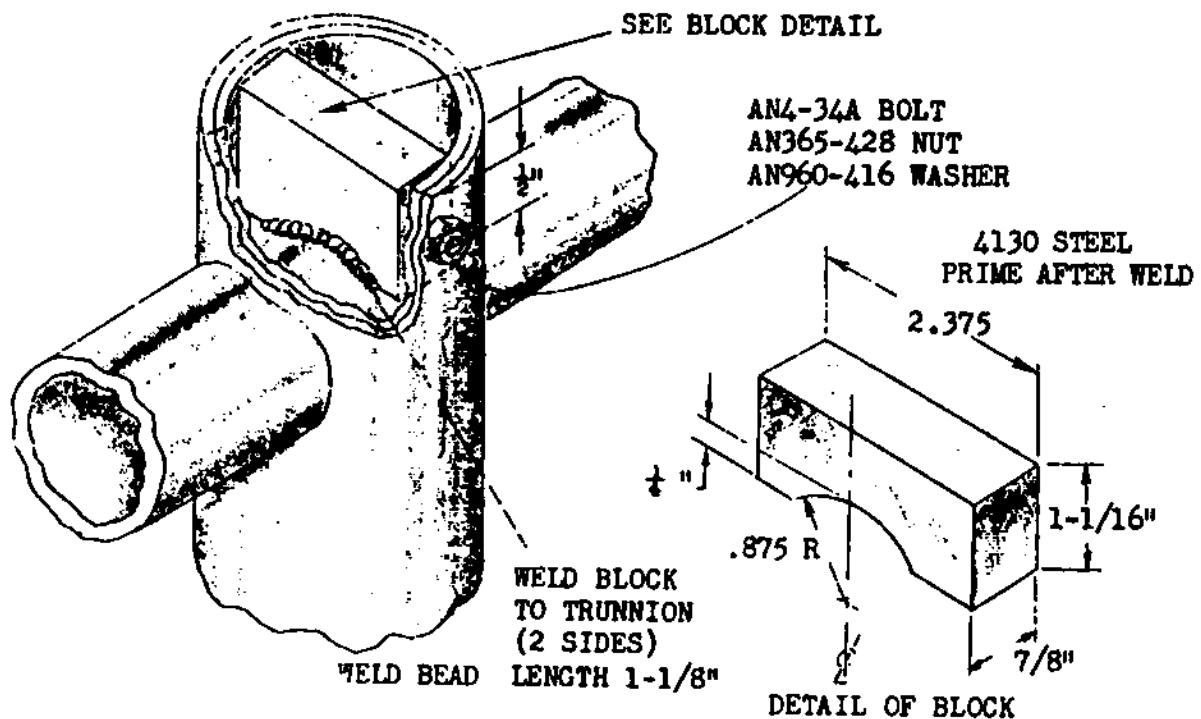
The following is a factory approved repair procedure for securing the trunnion to the strut in the event of a failure where the manufacturing method was furnace brazing only without the weld.

As shown in sketch, shape a block of 4130 steel to size, insert into top of strut and arc weld. Drill and ream to .250 + .0015 hole and install an AN4-34A Bolt, Nut and Washer. - .0006

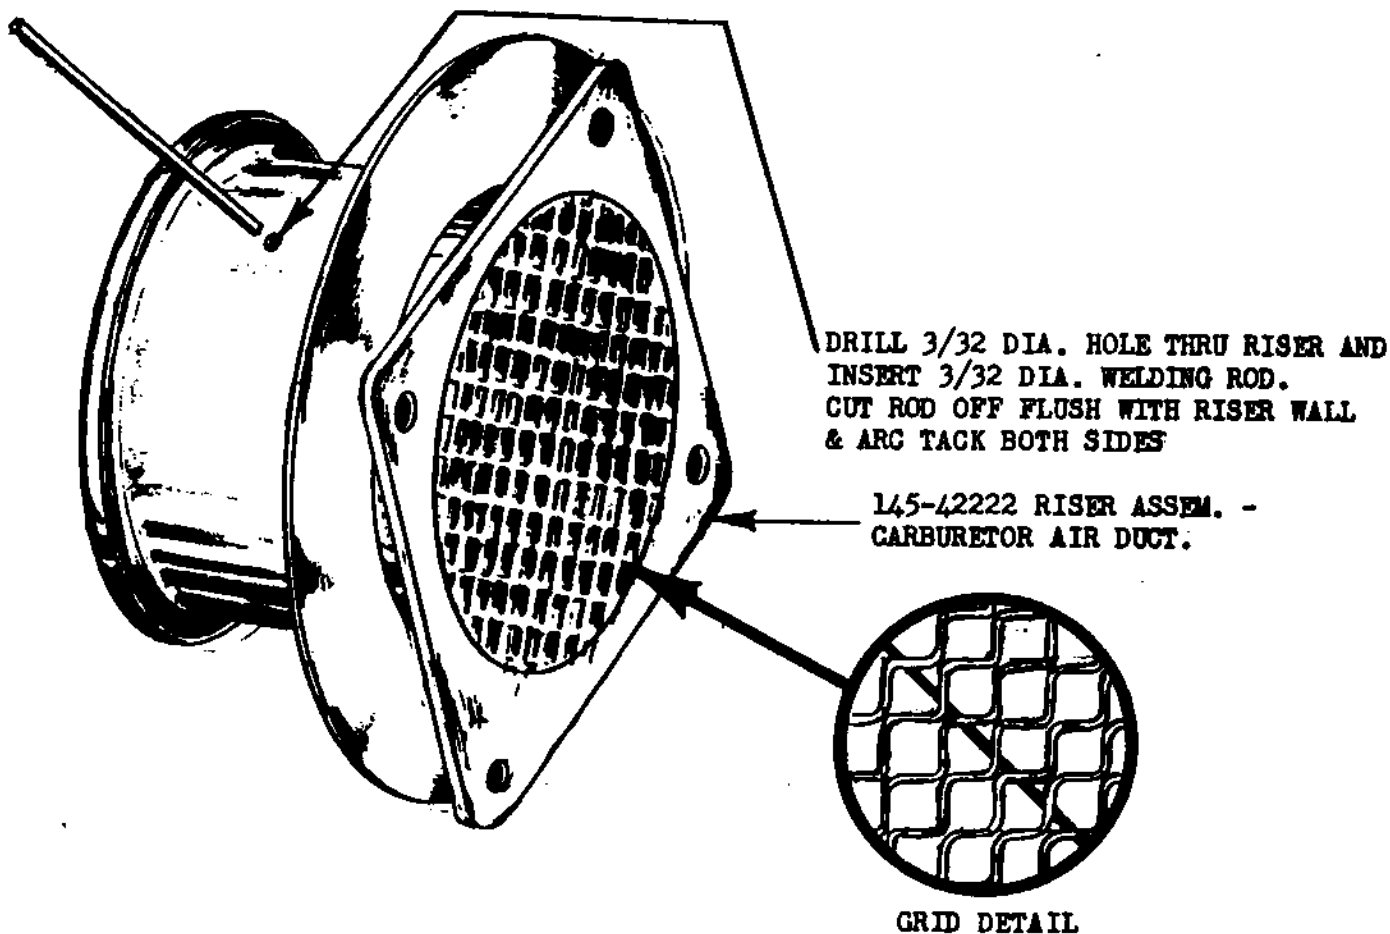
It has come to the factory's attention, that in one instance on an early model Continental powered Navion, the grid plates in the carburetor air Riser Assembly, part No. 145-42222, became loose during flight and jammed into the carburetor throat in such a way as to restrict carburetor air-flow.

To preclude the possibility of this trouble recurring, it is recommended that the grid plates in the riser be inspected for security of attachment at next engine or carburetor overhaul and a section of 3/32 diameter welding rod installed through the center of the grid and riser sidewalls as shown in sketch below.
