FIELD SERVICE BULLETIN

No. 9

EXHAUST TAIL PIPE WELD REWORK

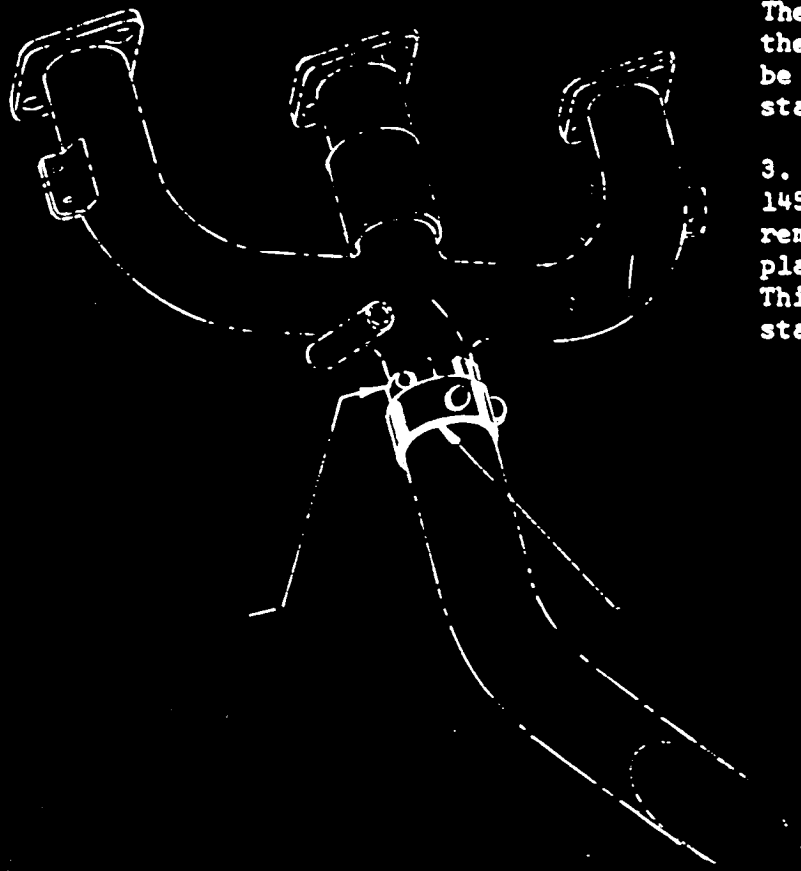
2. Inspect the upper edge of 145-42101-51 and -52 exhaust stack tail pipes, for two welded spot beads. These beads should appear just above the 145-42104 clamp. The beads should be on the face and aft side of the stack and approximately 3/32 inch high.

3. If the beads do not exist, the 145-42101-51 and -52 stacks should be removed and two gas-welded spot beads placed on the upper edge of the stack. This bead is necessary to prevent stack from slipping from under clamp.
