FIGURE B-6. LIGHTENING HOLE FLANGE REPAIR

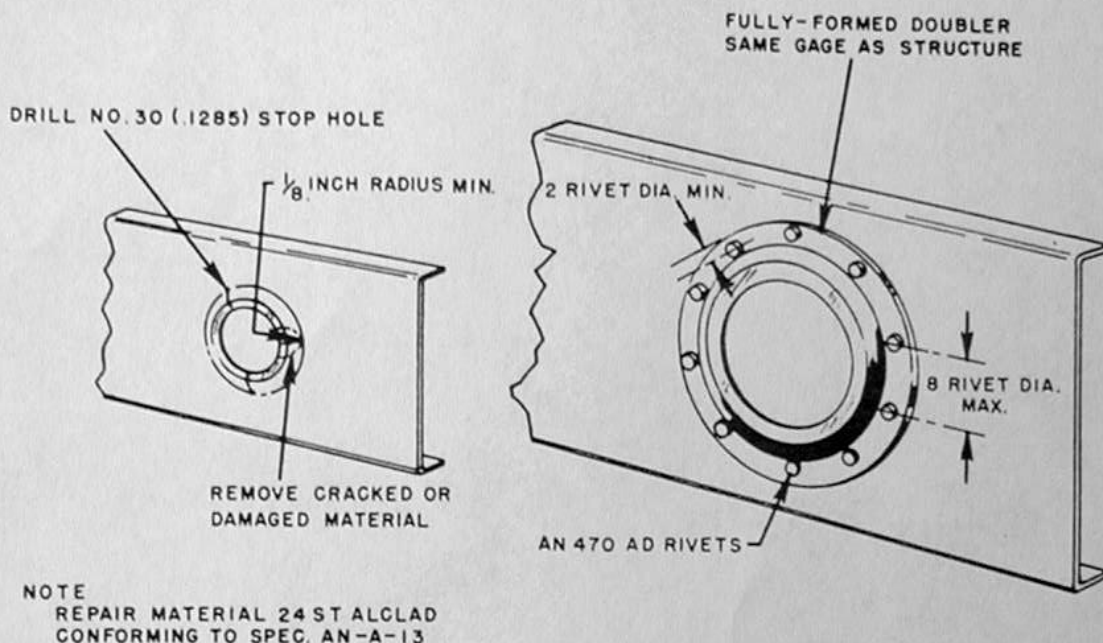
Cracked or torn lightening hole flanges, where the damage does not extend more than $\frac{4}{3}$ the width of the flange, may be repaired as shown in the Figure. Drill No. 30 (.1285) stop hole at the ends of all cracks. Remove the cracked or damaged material by trimming the flange of the lightening hole back to the stop drill hole, with a $\frac{1}{8}$ inch minimum radius. If desired, the entire flange may be removed. Smooth all edges to remove burrs. Cut a

doubler of the same material and thickness as the existing structure, and form flanges to match the original part. Attach the formed doubler to the existing structure with AN470AD rivets, using the size indicated in the table. Space rivets at approximately $\frac{1}{4}$ times the diameter of the lightening hole; but not greater than eight rivet diameters; maintaining a minimum edge distance of two rivet diameters.

RIVET SIZES FOR RIB REPAIRS							
Material Gage (inches)	.016	.020	.025	.032	.040	.051	.064
Rivet Diameter (inches)	3/32	3/32	1/8	5/32	5/32	3/16	3/16
The above values are the preferred AN470AD rivet sizes to be used with various gages of 24ST alclad.
