## APPENDIX II

## TYPICAL REPAIR ILLUSTRATIONS

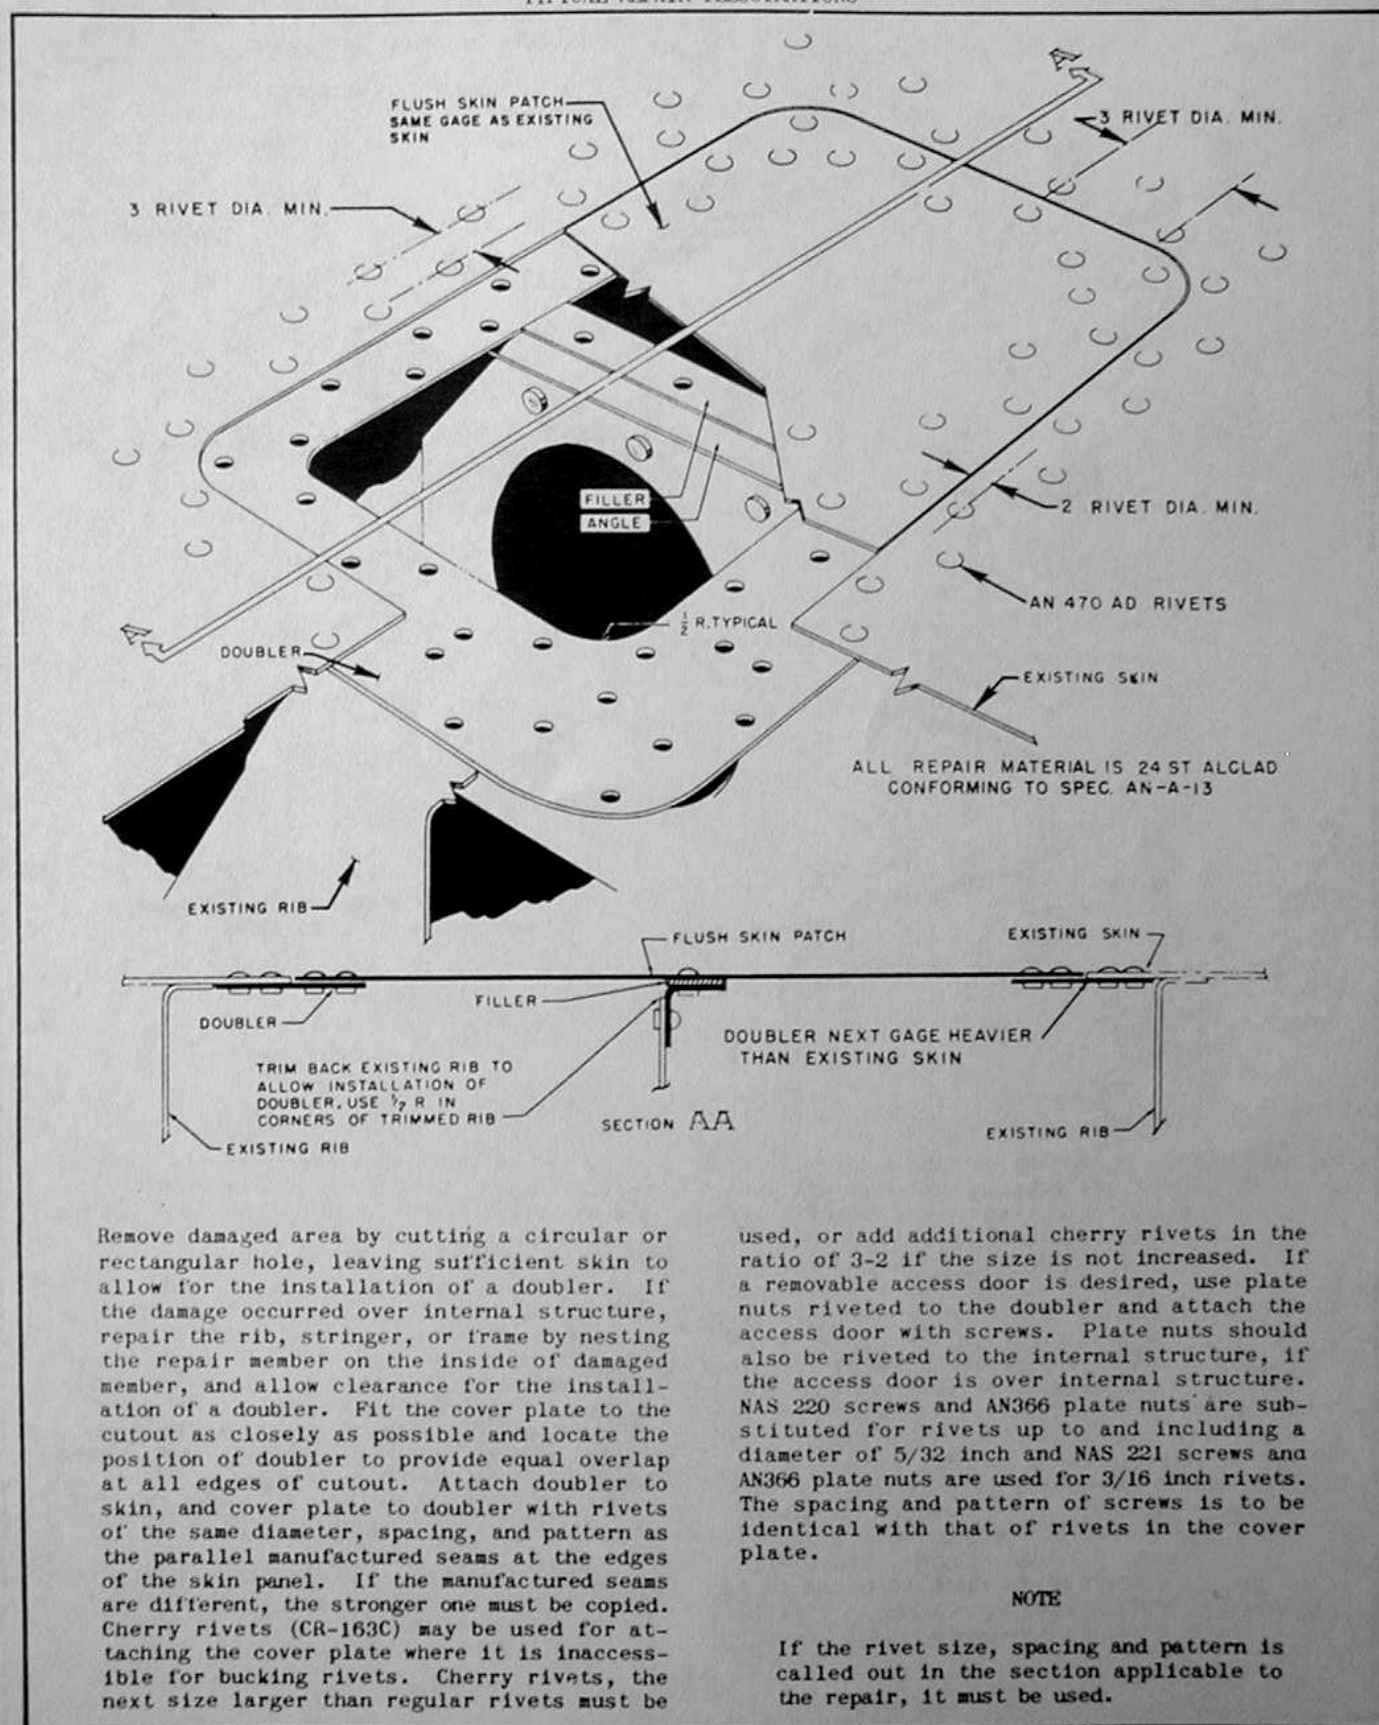
FIGURE B-1. FLUSH SKIN PATCH
