FIGURE B-2. LEADING EDGE FLUSH SKIN PATCH

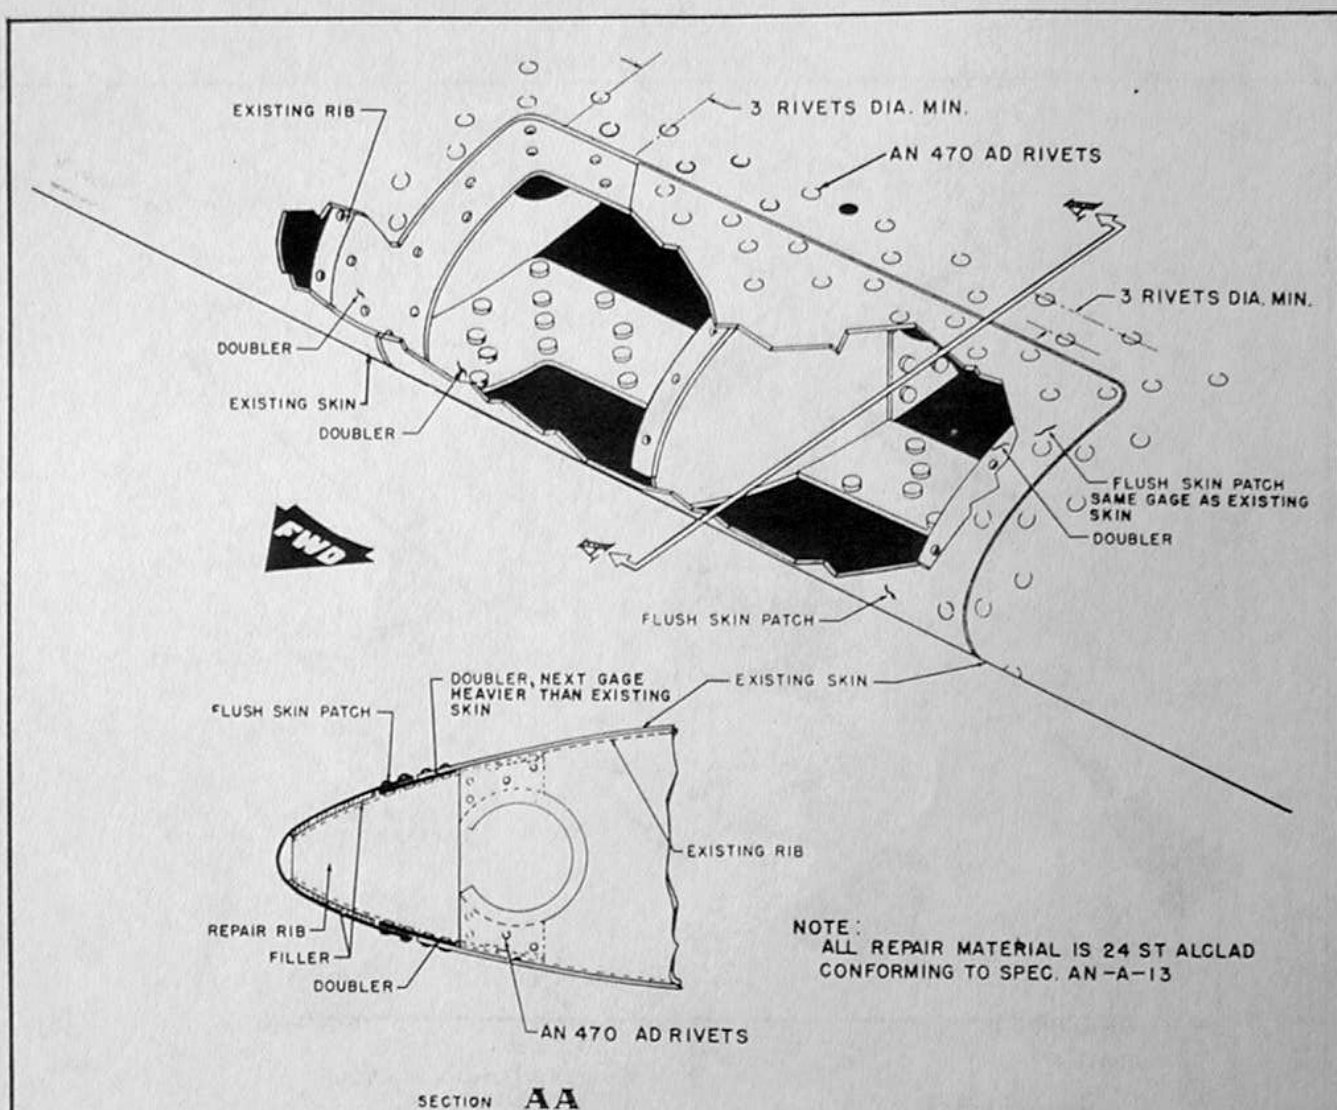
Remove damaged area by cutting a circular or rectangular hole, leaving sufficient skin to allow for the installation of a doubler. If the damage occurred over internal structure, repair the rib, stringer, or frame by nesting the repair member on the inside of damaged member, and allow clearance for the installation of a doubler. Fit the cover plate to the cutout as closely as possible and locate the position of doubler to provide equal overlap at all edges of cutout. Attach doubler to skin, and cover plate to doubler with rivets of the same diameter, spacing, and pattern as the parallel manufactured seams at the edges of the skin panel. If the manufactured seams are different, the stronger one must be copied. Cherry rivets (CR-163C) may be used for attaching the cover plate where it is inaccessible for bucking rivets. Cherry rivets, the next size larger than regular rivets must be

used, or add additional cherry rivets in the ratio of 3-2 if the size is not increased. If a removable access door is desired, use plate nuts riveted to the doubler and attach the access door with screws. Plate nuts should also be riveted to the internal structure, if the access door is over internal structure. NAS 220 screws and AN366 plate nuts are substituted for rivets up to and including a diameter of 5/32 inch and NAS 221 screws and AN366 plate nuts are used for 3/16 inch rivets. The spacing and pattern of screws is to be identical with that of rivets in the cover plate.

If the rivet size, spacing and pattern is called out in the section applicable to the repair, it must be used.
