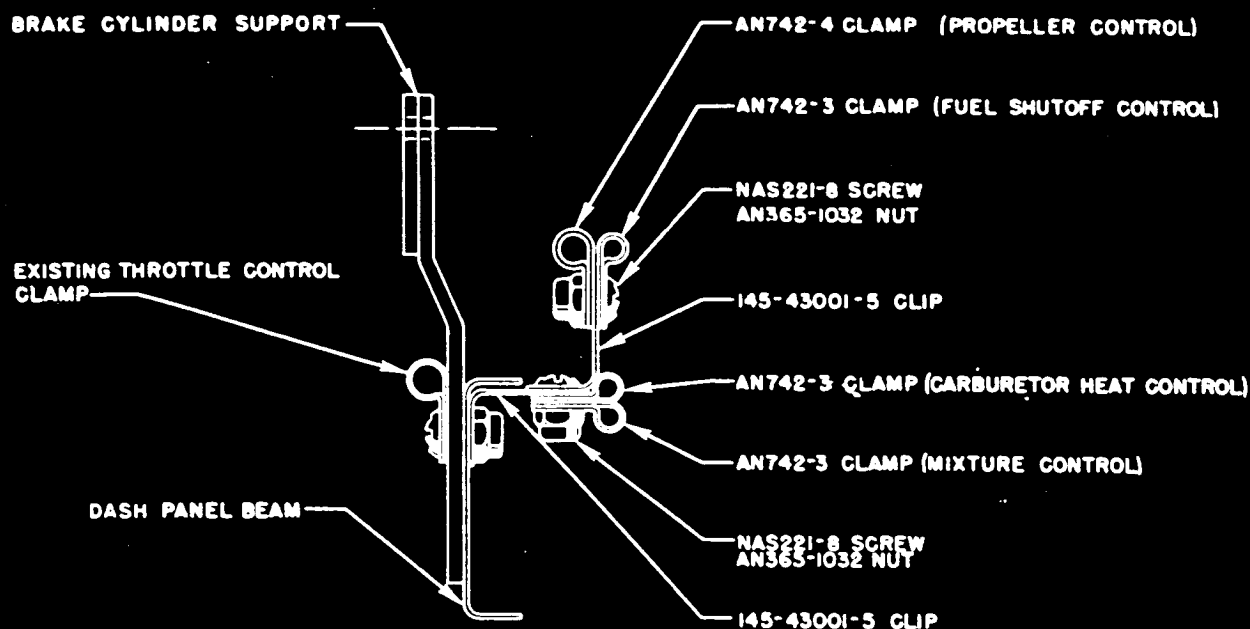
145-44-176

VIEW FORWARD TOWARD FIREWALL

See figure 1.

8. Remove screw (12 inches aft of firewall) in dash panel right-hand beam. Attach propeller control and three engine control Bowdenite housings to beam with removed screw, two 145-43001-5 clips, two new NAS 221-8 screws, new AN365-1032 nuts, and three removed AN742-3 clamps.

9. Counting from forward face of the engine crankcase, remove fifth, sixth, tenth, and eleventh bolts from upper parting line of the crankcase.
10. Install two new 145-43023 brackets on left side of crankcase, using the four bolts, nuts, and Palnuts previously removed. Torque nuts to 75 inch-pounds.

11. Install the AN316-4R nut and AN486-2 clevis on forward end of propeller control, and attach temporarily to propeller control valve arm, using AN24-10 bolt and AN320-4 nut. The head of bolt should be down to provide clearance for oil hose from propeller.

12. Attach control housing to forward 145-43023 bracket with two AN742-4 clamps, two previously removed NAS 221-8 screws, and AN365-1032 nuts.
13. Attach control to forward hole in aft 145-43023 bracket with AN742-4 clamp, NAS 221-8 screw, and AN365-1032 nut, leaving all slack in control housing between firewall and engine.

14. Adjust propeller control as directed in NAVion Service Manual. When adjustment is complete, tighten locknut on clevis, and install AN380-2-2 cotter in AN24-10 bolt.
